031 – December 2010

Queen Mary 2 catastrophic explosion causes total power outage

Total power outage due to catastrophic engine room explosion on *QM2*

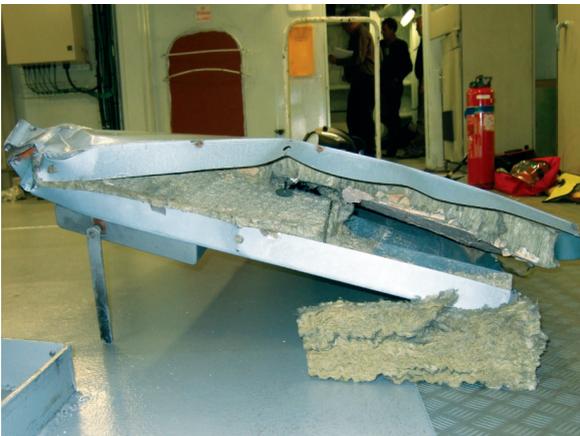
According to the MAIB Marine Accident Investigation Branch report, the situation was more serious than passengers knew. The report goes on to say that the explosion was forceful enough to damage steel doors and casings and buckle stiffeners on the bulkhead of a compartment within the aft main switchboard room. The steel cover plate on a cross-flooding duct was blown out into the main switchboard room. The MAIB's investigation revealed that the capacitor had "deteriorated gradually", yet monitoring devices did not detect the problem. Therefore the MAIB issued strong recommendations to cruise lines and other ship owners to prevent similar events from taking place. The recommendations include inspecting the capacitors for signs of physical distortion, ensuring

Mangled steel door from the aft main switchboard room
Source: MAIB SAFETY BULLETIN 4/2010, www.maib.gov.uk

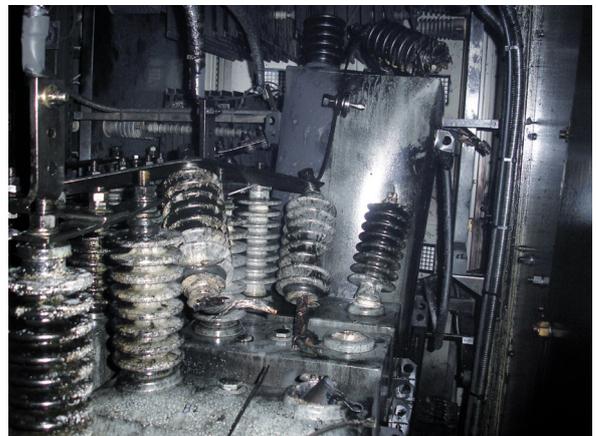
Early in the morning on 23 September 2010 at 0426 hours, the passenger ship *RMS Queen Mary 2* was approaching Barcelona when one out of 12 capacitors in a harmonic filter failed. Leaking oil was sprayed onto high voltage bars, causing a major arc flash event, in other words – a heavy explosion near one of *QM2*'s main electric switchboard rooms. The harmonic filter* was located in a compartment within the aft main switchboard room. The explosion resulted in extensive damage to the surrounding electric panels and caused the

Harmonic filter compartment – source of explosion
Source: MAIB SAFETY BULLETIN 4/2010, www.maib.gov.uk

that cooling and ventilation systems are operating normally, testing monitoring devices and checking for cleanliness of exposed conductors and chaffing damage on high voltage cables.
