031 – December 2010

Queen Mary 2 catastrophic explosion causes total power outage

Total power outage due to catastrophic engine room explosion on *QM2*

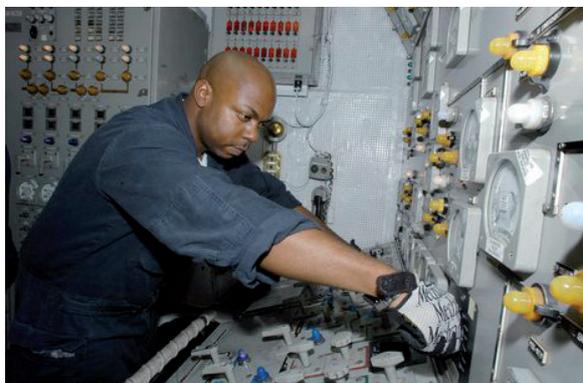
Partial view switchboard

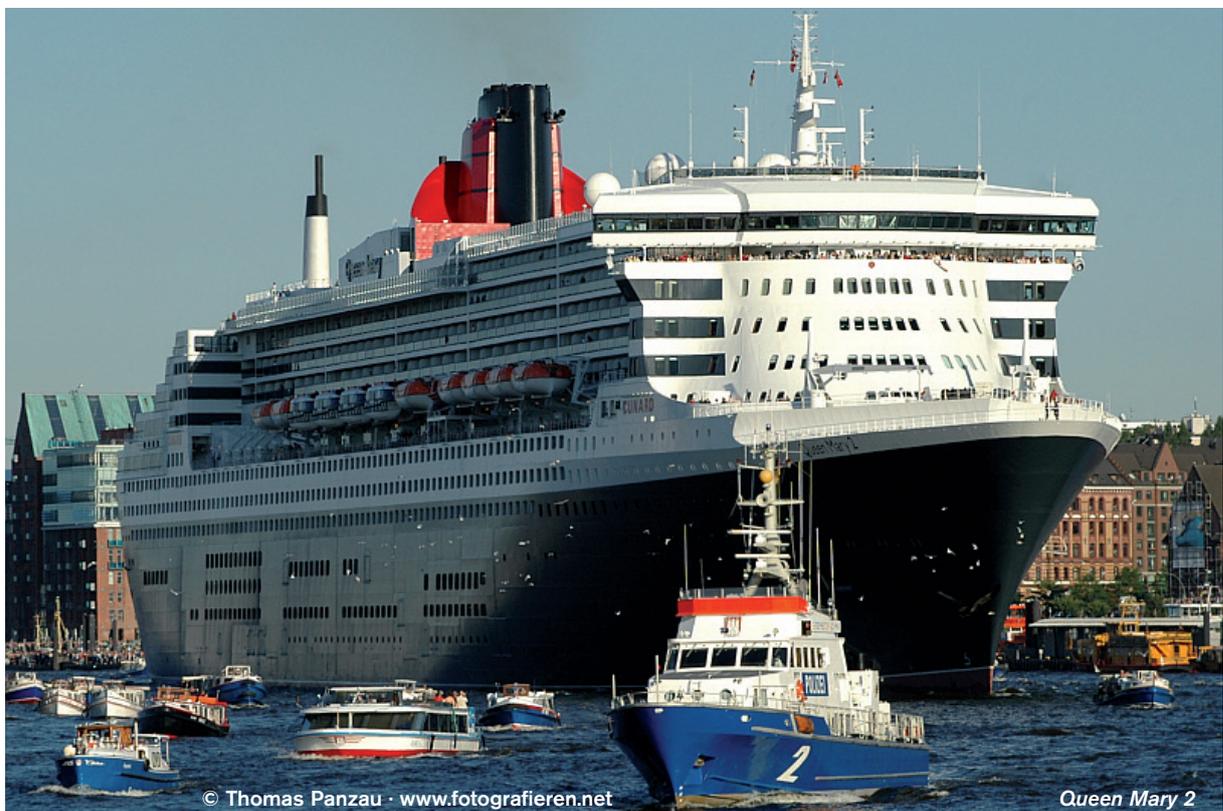
Early in the morning on 23 September 2010 at 0426 hours, the passenger ship *RMS Queen Mary 2* was approaching Barcelona when one out of 12 capacitors in a harmonic filter failed. Leaking oil was sprayed onto high voltage bars, causing a major arc flash event, in other words – a heavy explosion near one of *QM2*'s main electric switchboard rooms. The harmonic filter* was located in a compartment within the aft main switchboard room. The explosion resulted in extensive damage to the surrounding electric panels and caused the

vessel to black out. The *Queen Mary 2* was drifting off the coast of Barcelona with no power! After approximately one hour the ship slowly started to move and limping towards port.

According to the MAIB Marine Accident Investigation Branch report, the situation was more serious than passengers knew. The report goes on to say that the explosion was forceful enough to damage steel doors and casings and buckle stiffeners on the bulkhead of a compartment within the aft main switchboard room. The steel cover plate on a cross-flooding duct was blown out into the main switchboard room. The MAIB's investigation revealed that the capacitor had "deteriorated gradually", yet monitoring devices did not detect the problem. Therefore the MAIB issued strong recommendations to cruise lines and other ship owners to prevent similar events from taking place. The recommendations include inspecting the capacitors for signs of physical distortion, ensuring

that cooling and ventilation systems are operating normally, testing monitoring devices and checking for cleanliness of exposed conductors and chaffing damage on high voltage cables.
