031 – December 2010

Queen Mary 2 catastrophic explosion causes total power outage

Total power outage due to catastrophic engine room explosion on *QM2*

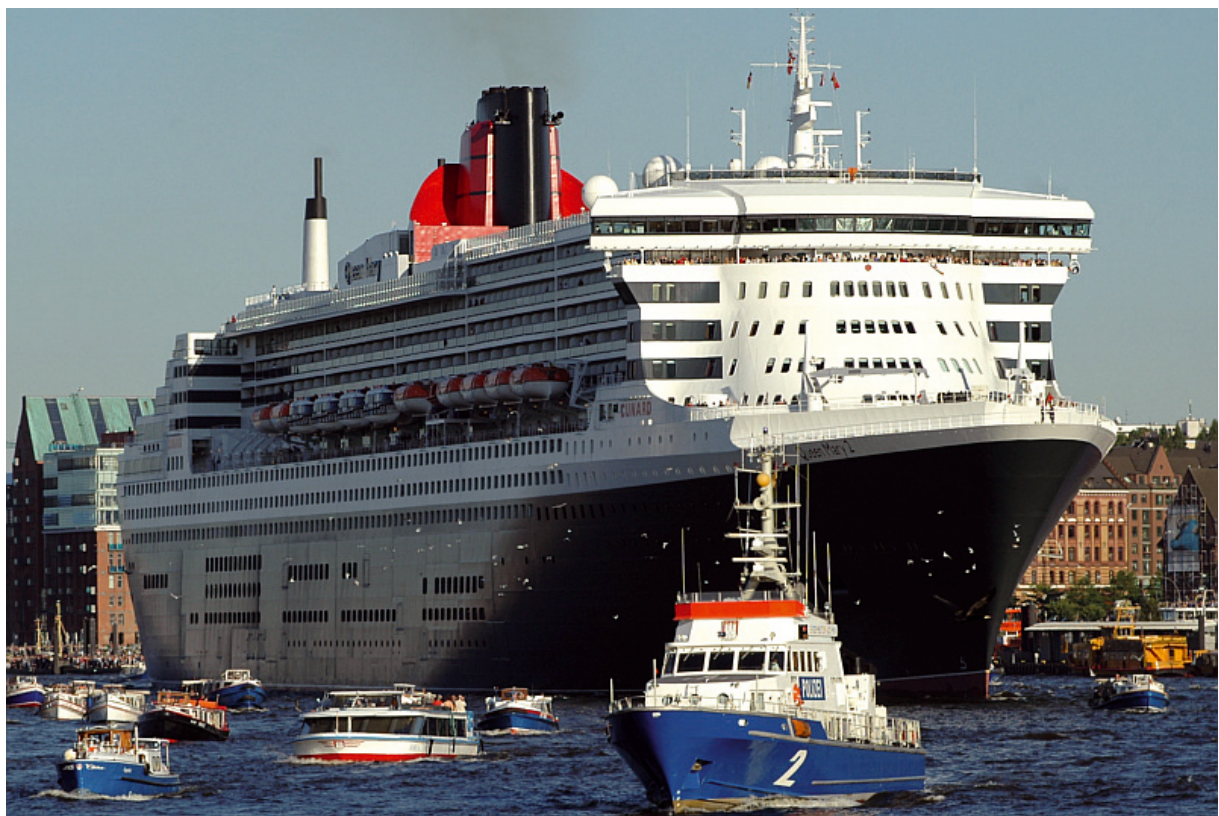
Early in the morning on 23 September 2010 at 0426 hours, the passenger ship *RMS Queen Mary 2* was approaching Barcelona when one out of 12 capacitors in a harmonic filter failed. Leaking oil was sprayed onto high voltage bars, causing a major arc flash event, in other words – a heavy explosion near one of *QM2*'s main electric switchboard rooms. The harmonic filter* was located in a compartment within the aft main switchboard room. The explosion resulted in extensive damage to the surrounding electric panels and caused the

vessel to black out. The *Queen Mary 2* was drifting off the coast of Barcelona with no power! After approximately one hour the ship slowly started to move and limping towards port.

According to the MAIB Marine Accident Investigation Branch report, the situation was more serious than passengers knew. The report goes on to say that the explosion was forceful enough to damage steel doors and casings and buckle stiffeners on the bulkhead of a compartment within the aft main switchboard room. The steel cover plate on a cross-flooding duct was blown out into the main switchboard room. The MAIB's investigation revealed that the capacitor had "deteriorated gradually", yet monitoring devices did not detect the problem. Therefore the MAIB issued strong recommendations to cruise lines and other ship owners to prevent similar events from taking place. The recommendations include inspecting the capacitors for signs of physical distortion, ensuring

that cooling and ventilation systems are operating normally, testing monitoring devices and checking for cleanliness of exposed conductors and chaffing damage on high voltage cables.

To be fully dead in the water takes many, many system failures! Floating cities like the *QM2* or *Carnival Splendor* must not suffer from a total breakdown of power! Their propulsion concept will have to be completely rearranged. IFEP Integrated Full Electric Propulsion will have to be abandoned and there will be a strict physical separation between main and auxiliary (emergency) power supply. Proactive retrograde steps toward minimum one direct drive for emergency operation controlled via

a conventional (simple) switchboard will have to be taken.
